Alaska Airlines Flight 261: Understanding the Systemic Contributors to Organizational Accidents

Christian G.W. Schnedler, Daniel Murphy, Steven J. Stumpp, Frantz St. Phar
Stevens Institute of Technology

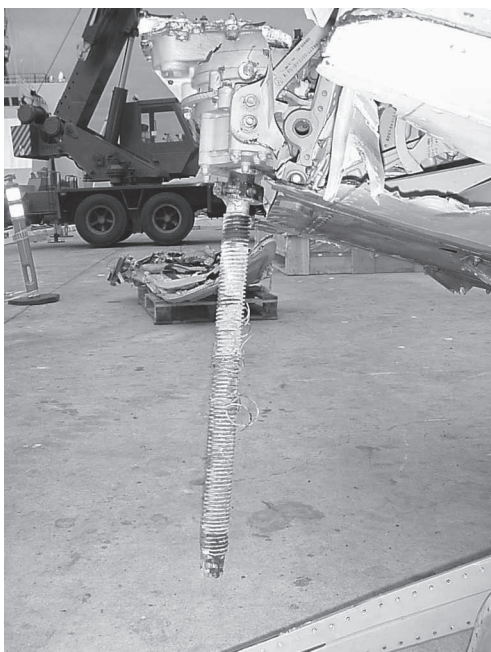
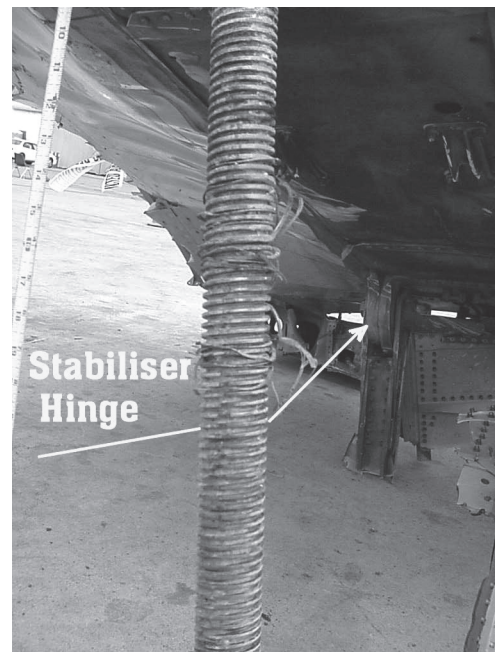
Figure 1. Jackscrew from Flight 261 Horizontal Stabilizer (NTSB)

tried in vain to right the plane, but their efforts failed. Flight 261 crashed January 31, 2000 at approximately 16:21 in the Pacific Ocean, 2.7 miles north of the Anacapa Islands, California. An investigation by the National Transportation Safety Board (NTSB) would later find the accident resulted from a failed jackscrew assembly controlling the horizontal stabilizer (see Figure 1).

- From the last end play check inspection in September 1997 to the crash, the wear rate of the nut threads was roughly 10 times what was expected with regular maintenance and use. Upon recovery of the wreckage, the acme nut threads showed wear of 90%. At the nut’s wear limit (when the nut should be replaced) it should exhibit wear of 22%.

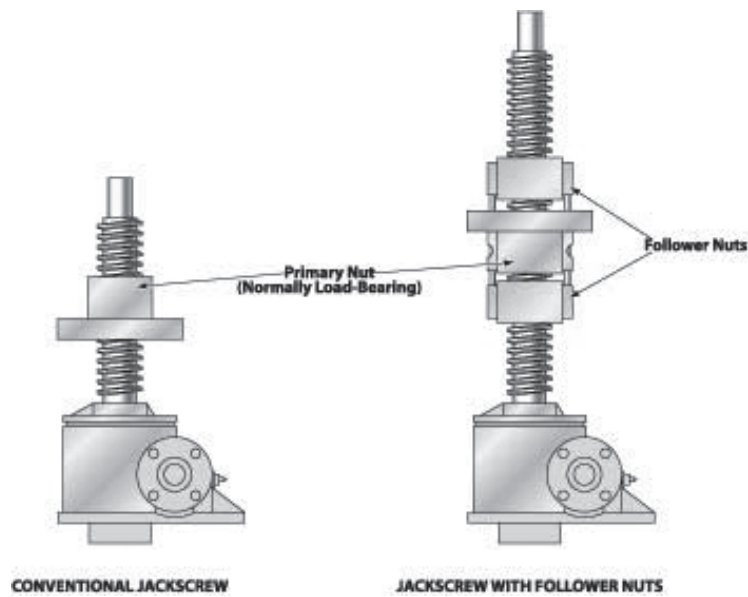
Figure 5. Original and Redesigned Jackscrew Assembly (Fraley et al.)

Alarmed, KSC formed a team to design an improved jackscrew assembly able to be more easily monitored by maintenance crew members and retrofitted with a fail-safe feature in case of damage to the primary jackscrew. This crew would find the solution to these objectives in a design based on redundant follower nut(s) as shown in Figure 5.
