Alaska Airlines Flight 261: Understanding the Systemic Contributors to Organizational Accidents

Christian G.W. Schnedler, Daniel Murphy, Steven J. Stumpp, Frantz St. Phar
Stevens Institute of Technology

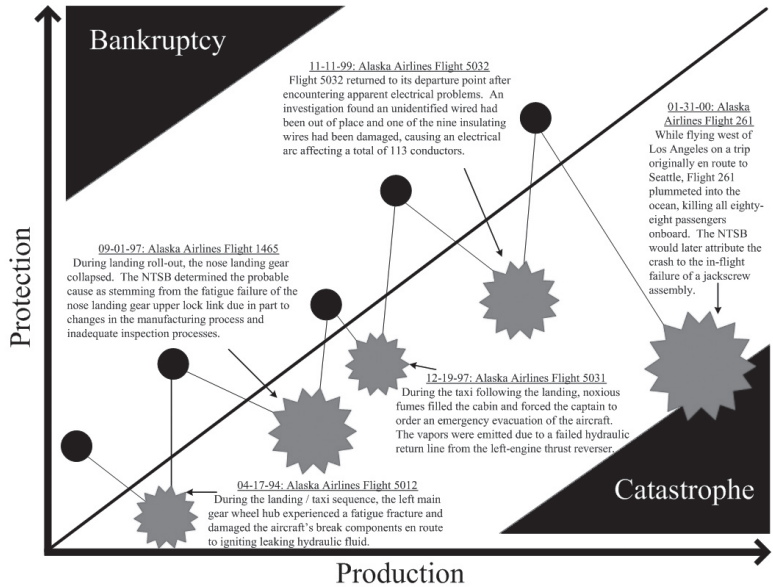
Figure 4. Alaska Airline’s Production-Protection Space (NTSB Accident Reports)

Figure 4 for an adaptation of Reason’s Production-Protection Space representing the progression of Alaska Airlines along the production-protection continuum.
